Great Plains Energy Codes Conference

Case Study in Nebraska -
What Happens When a Home Does Not Meet Code
After Being Passed By The Local Code Jurisdiction?

CASE STUDY IN NEBRASKA

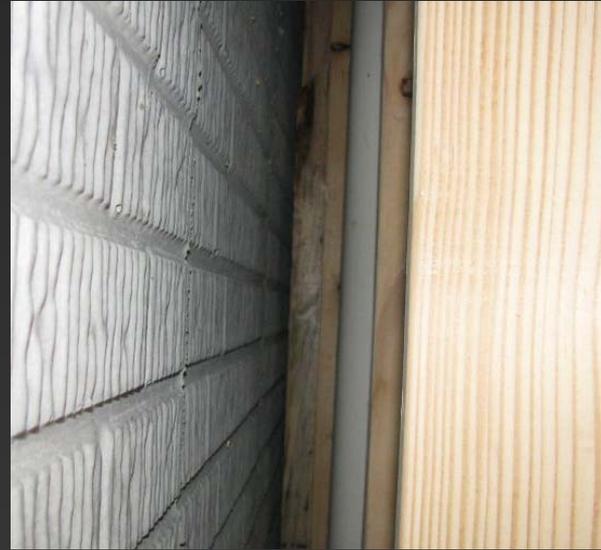
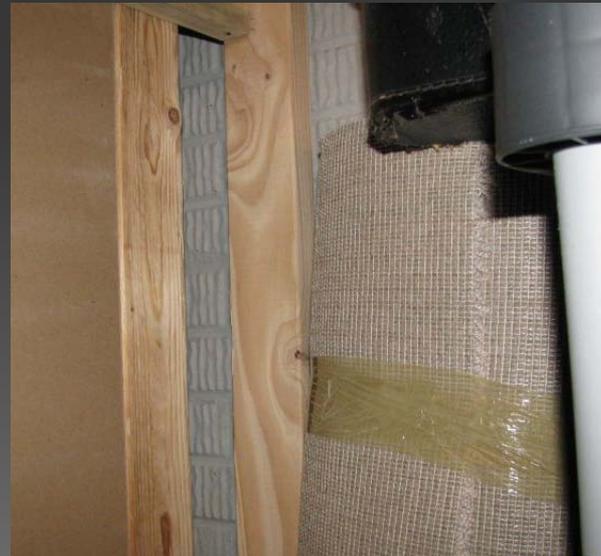
The submitted *RESCheck* Compliance Certificate indicated an R-4.0 continuous insulation would be installed on the top four feet of all of the basement walls.

The visual inspection completed on-site showed that no interior or exterior basement wall insulation had been installed.

- ◉ What was required to bring this home into compliance with the Code?
 - › Basement Walls
 - The basement wall finishes were removed and reinstalled following the installation of R-13 fiberglass batts in the framed wall cavities
 - The unfinished walls in the storage area remained uninsulated
 - › Exterior Framed Walls
 - R-13 batt insulation was installed in the uninsulated attic kneewall
 - › Attic/Ceiling Insulation
 - The existing R-44 insulation was appropriately leveled to provide a consistent insulation value

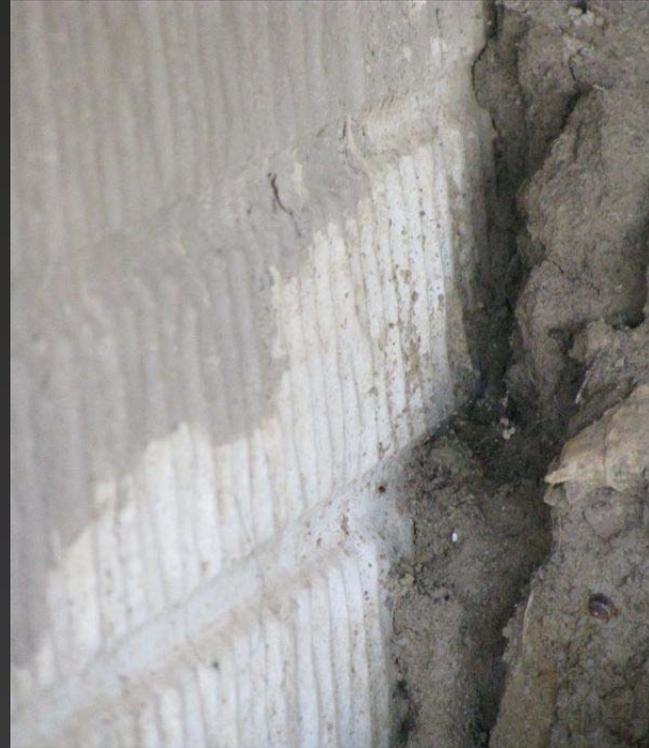
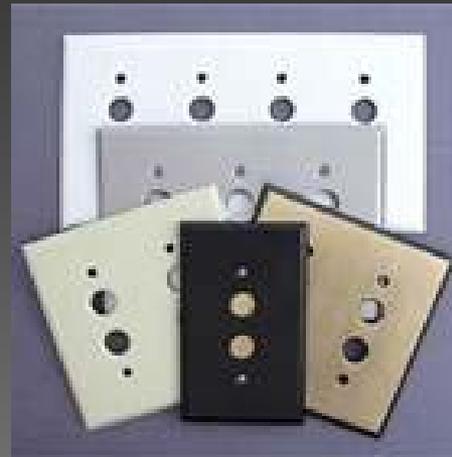
Basement Walls

In the finished area of the basement electrical and speaker wall plates were removed in three locations showing no insulation had been installed on the wall prior to the installation of the finish system.

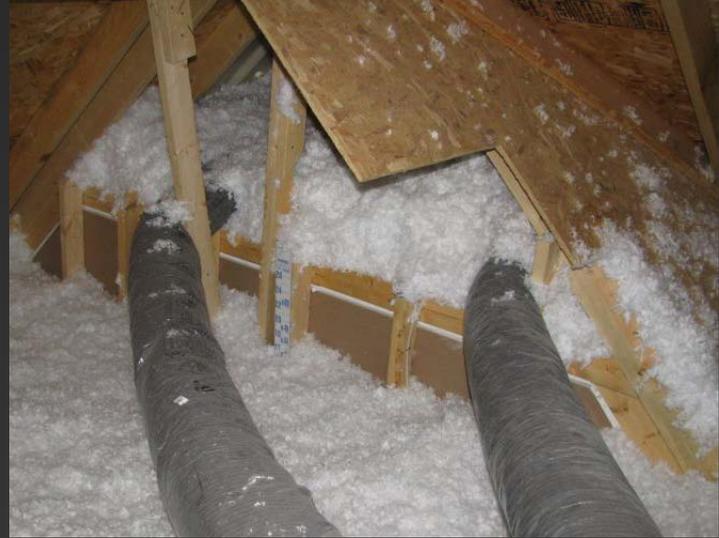
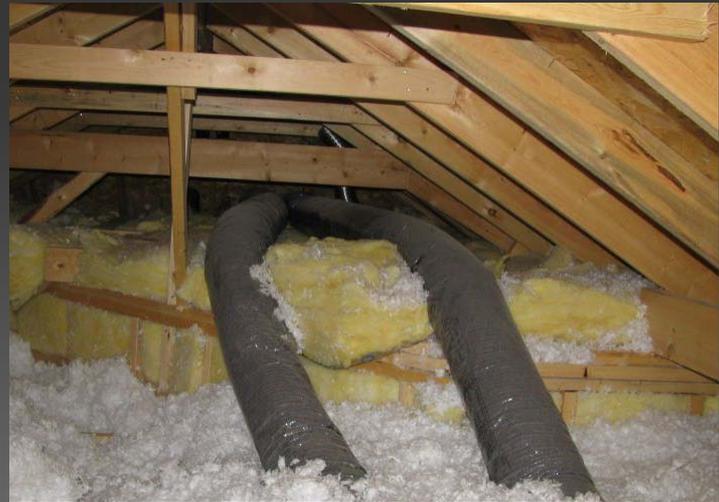
Exterior Framed Walls

Compliance Certificate indicated that all exterior framed walls would have a R-13 cavity insulation.

The inspection of the attic area revealed that the exterior wall between the raised ceiling area of one of the bedrooms and the unconditioned attic was uninsulated.

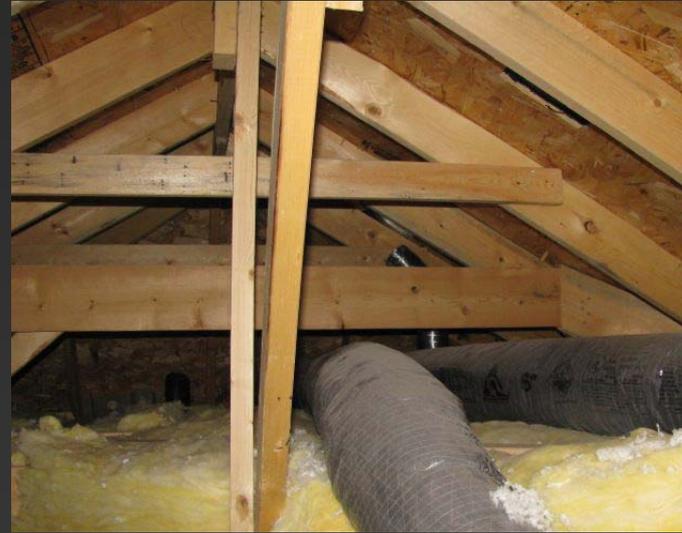
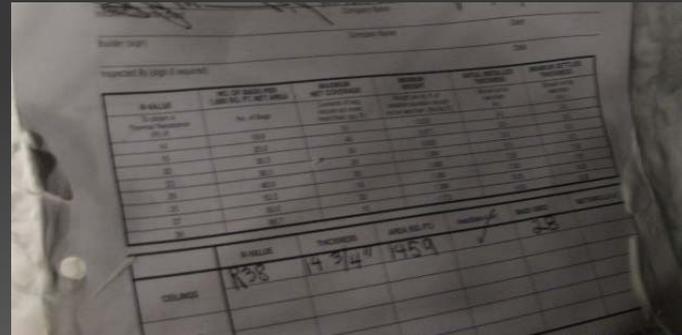
Attic/Ceiling Insulation

Compliance Certificate indicated that an R-50 insulation would be installed in the flat ceiling areas of the home and an R-38 would be installed in the cathedral ceiling areas of the home.

- The cathedral ceiling areas had an R-38 batt insulation.
- The flat ceiling areas had a blown fiberglass insulation product installed with a labeled U-value of R-38.

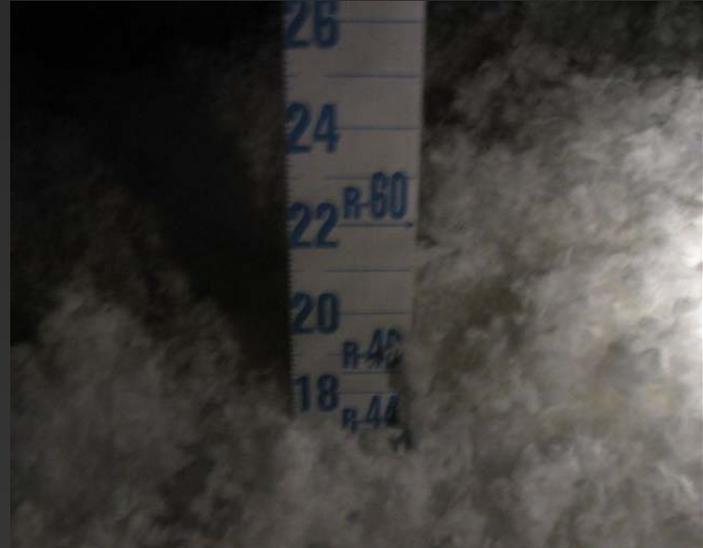
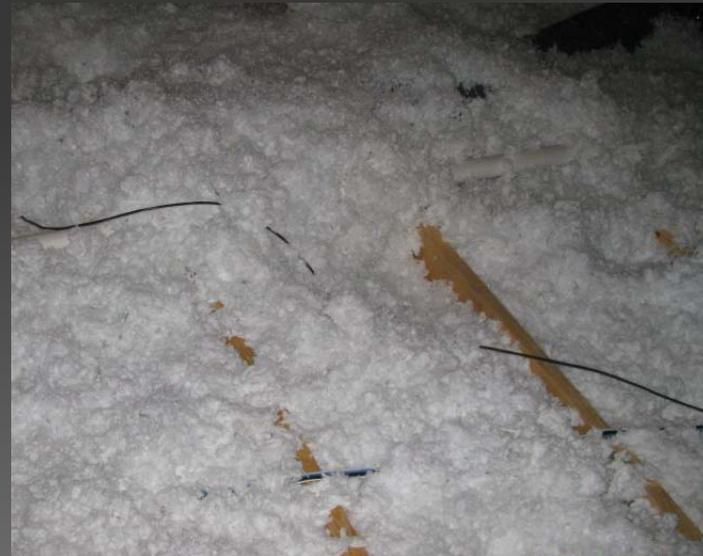
Attic/Ceiling Insulation

- Tapes and density testing of the blown product indicated that the installed depth of the product in much of the attic provided an R-value of 44.
- The depth of the blown product was inconsistent with building framing showing through the insulation in many areas.

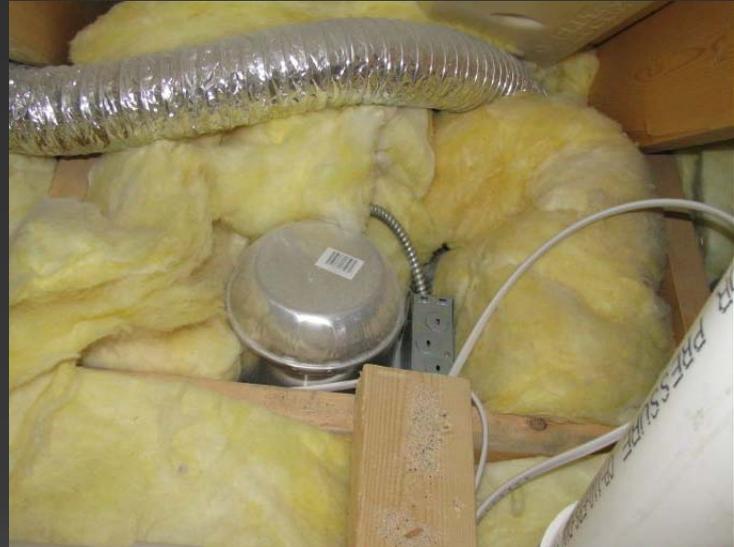
Section 502.1.3 of the 2003 IECC requires that recessed light fixtures installed in the building envelope be either 1) IC rated fixtures with no penetrations between the inside of the fixture and the ceiling cavity or 2) non-IC rated and installed inside a sealed box.

During the inspection a number of fixtures were located that penetrated the building envelope, were not in a sealed box and showed no IC rating label.

- ◉ What was required to bring this home into compliance with the Code?
 - › Recessed Light Fixtures
 - Documentation was provided by the installer verifying the IC rating of the fixtures
 - › Equipment Sizing
 - Appropriate HVAC sizing calculation were completed and an appropriately sized air conditioner was installed
 - › Duct Insulation
 - Following appropriate duct sealing, documentation was provided showing that a minimum of 3" of blown insulation totally surrounded all supply and return ducts in the attic
 - › Duct Sealing
 - Both the City and NEO approved the use of an interior blown duct sealer to seal the ductwork in the home

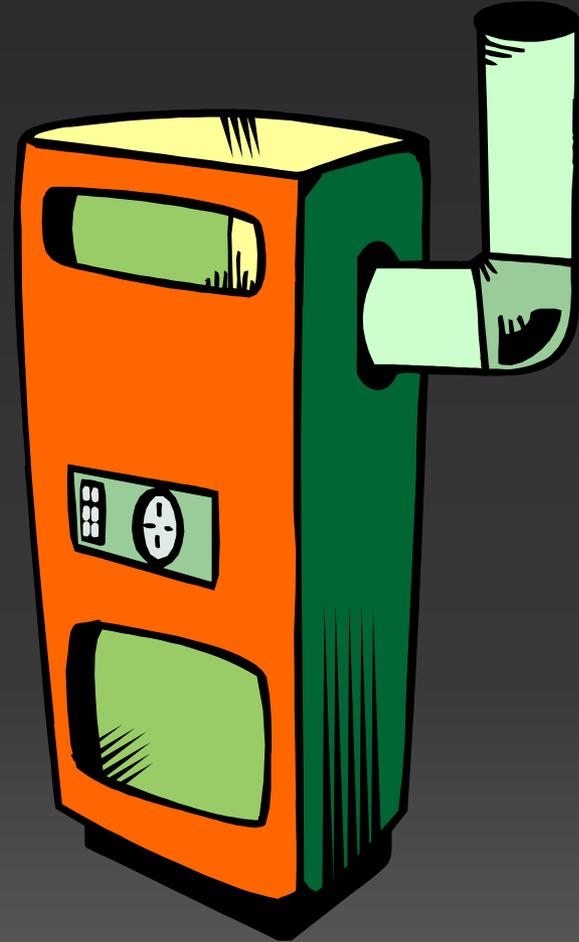
Equipment Sizing

Section 503.3.1 of the 2003 IECC states: *Heating and cooling design loads for the purpose of sizing systems and equipment shall be determined in accordance with the procedures described in the ASHRAE Fundamentals Handbook.*

The residence was heated by a 90.0% efficient gas furnace with a heating capacity of 116,000 MBTUH and cooled by an air conditioner with a Seasonal Energy Efficiency Rating (SEER) rating of 13.2 and a cooling capacity of 55,500 Btuh (**5.0 tons**).

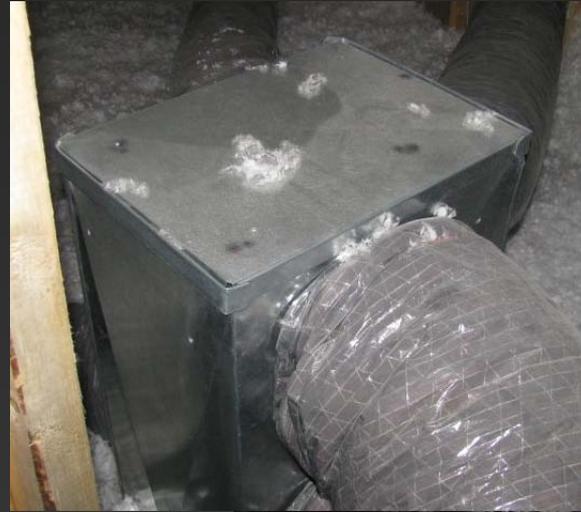
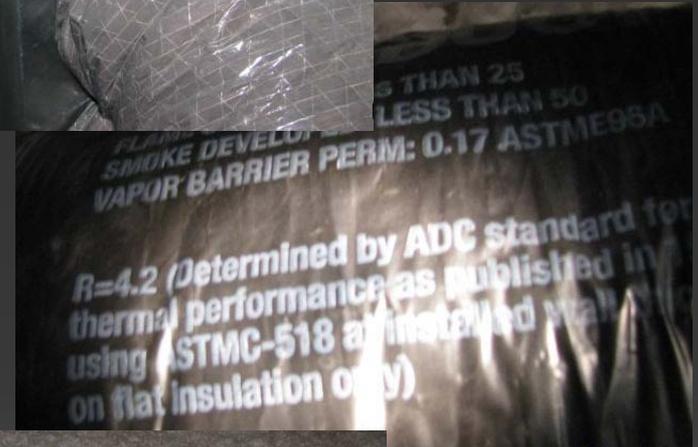
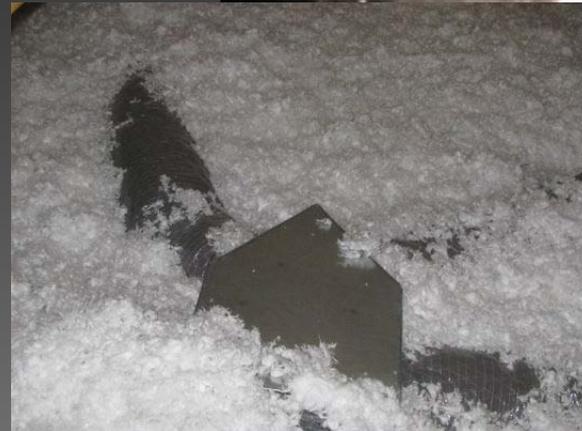
Duct Insulation

Section 503.3.3.4.3 of the 2003 IECC states: *All supply and return air ducts and plenums installed as part of an HVAC air distribution system shall be thermally insulated in accordance with Table 503.3.3.3.* The table indicates the minimum R-value requirement for ducts located in unconditioned attics in this climate zone is an R-8.0 on supply ductwork and an R-4.0 on return ductwork.

The flexible supply ductwork in the unconditioned attic had a marked R-value of 4.2 and the rigid ducts were uninsulated.

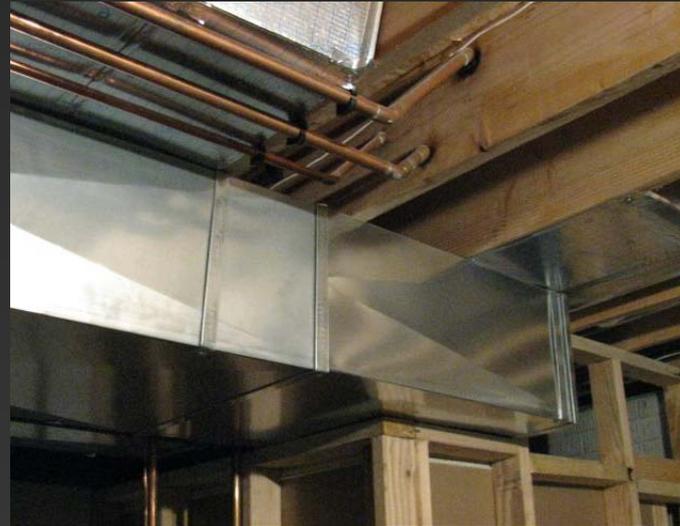
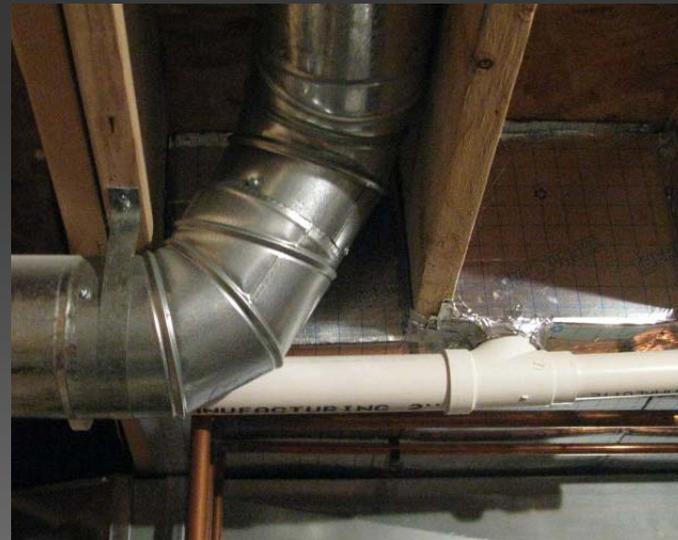
Duct Sealing

Section 503.3.3.4.3 of the 2003 IECC states: *All longitudinal and transverse joints, seams and connections in ductwork shall be securely fastened and sealed with welds, gaskets, mastics (adhesives), mastic-plus-embedded-fabric systems or tapes installed in accordance with the manufacturer's installation instructions.*

None of the visible supply and return ductwork located in the basement or the supply ductwork located in the attic was sealed or masticed.
