**FINAL TECHNICAL REPORT**

**Nebraska Photovoltaic System Case Study**  
**Water Pumping Application**

**January 2003**

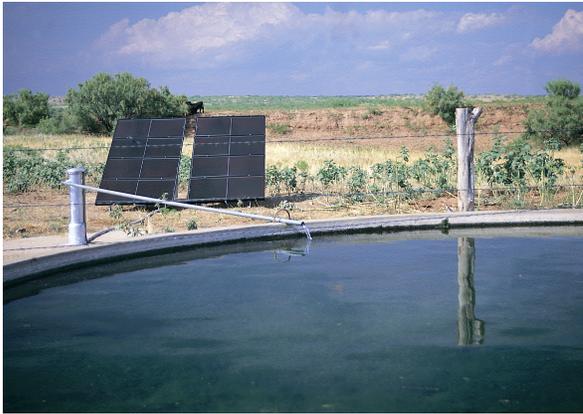
On September 8, 2001, ranch personnel constructed and checked the system support structures. They dug and poured the concrete footings to provide a stable platform for the solar panels. The next day, they anchored the structures to the footings and installed the panels onto the structure. They then made the connections and started the pump, assembling the system in about 12 hours.

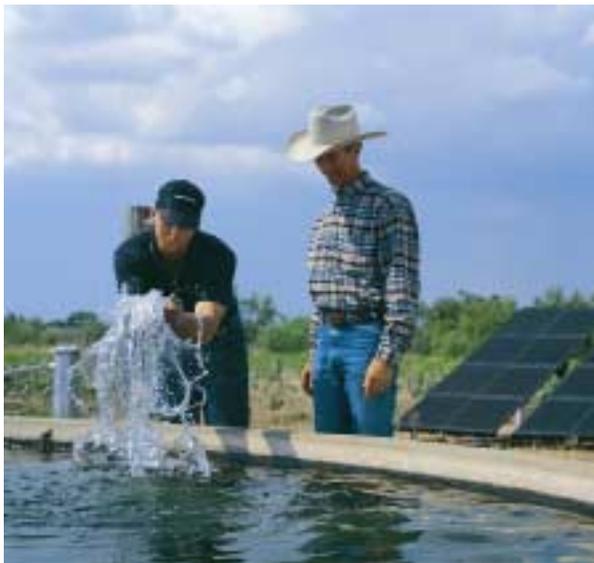
This system was a field test for new equipment; therefore, Grundfos initially installed a flow meter to record accurate production data. Upon initial startup, at approximately 3:00 p.m. on Sunday, September 9, 2001, the system pumped water at a rate of 23 gallons per minute ( $1.44 \times 10^{-3} \text{ m}^3/\text{s}$ ). Over the first week, the ranch recorded readings from the flow meter daily. The flow rates were as follows:
