# Appendix A: Energy Modeling

Project name: Nebraska  
 Model name: Single-Family  
 Location: Lincoln, NE

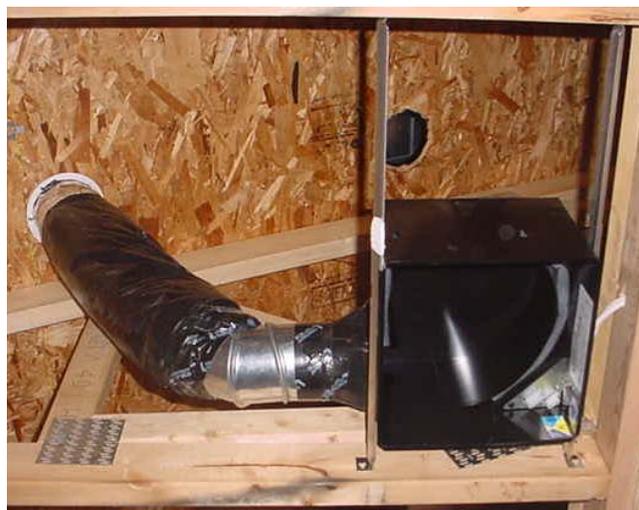
To minimize roof penetrations, the builder had originally tied the exhaust ducts for both fans into a single termination through the roof. Recognizing the negative impact all the elbows and impingements would have on the fan static pressure, CARB encouraged the builder to provide separate exhaust terminations for each fan. Shown on the right, the builder used a fitting to transition from the 4 inch fan outlet to 6 inch insulated flex duct. The duct was terminated directly out the roof with less than 5 feet of ductwork on each fan. Despite the extra efforts to reduce pressure drop, the fans did not achieve the Manufacturer’s rated airflow.

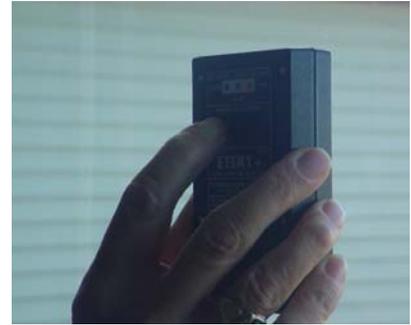
CARB performed a detailed audit of the appliances, lighting, equipment, and building specifications in the home. As shown on the right, a Low e Detector was used to verify the low e coating on the windows. During the audit, CARB noticed the stove had a recirculating range hood that did not exhaust to the outside. Although CARB had specified that all exhaust fans be vented to the outside, this is a common mistake. However, after the final testing was complete, the builder went to great lengths to replace the hood and provide proper venting to the outside.

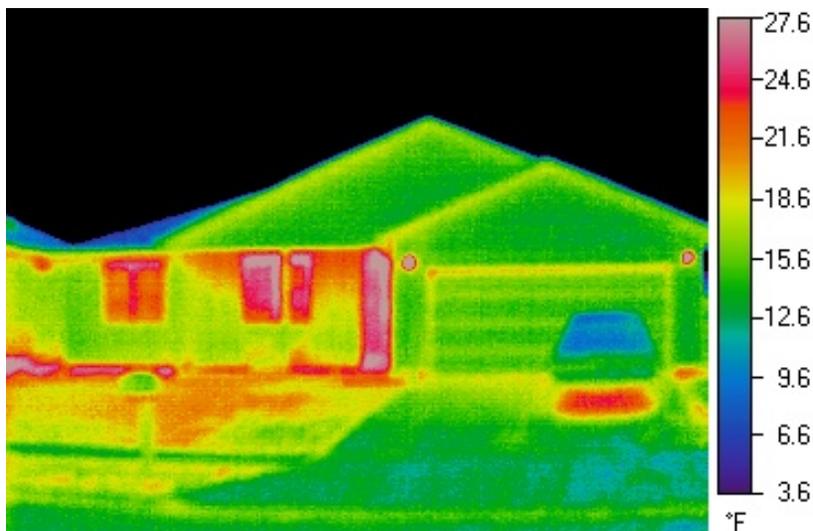
Date : 02/16/2005  
Emissivity : 1.00

The IR photographs show that there is less heat loss through the windows of the Prototype Home, a result of high performance glass. The heat loss of the above-grade walls is also greater in the Standard Practice Construction than that of the Prototype.

Infrared images are a valuable tool to help visualize the heat loss through the building envelope. The Nebraska Public Power District (NPPD) owns a number of Infrared (IR) Cameras, which are available on loan to interested parties. CARB was able to borrow an IR Camera during the performance testing to take pictures of both the Prototype Home and standard practice construction in the area. On the morning the exterior photographs were taken it was approximately 28° F outside. IR images are shown below.

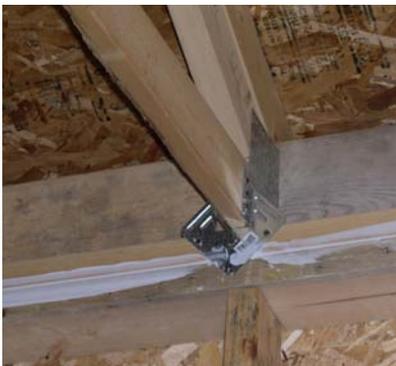
Incorrectly Installed Clip

Many builders are unaware of that these installation practices result in a frame that is both thermally and structurally weaker. It is simply more convenient to install them on the inside because it can be done from a standard ladder. In many cases, these cold spots in the drywall eventually lead to “ghosting”, a condition where the drywall blackens at each clip location. CARB continues to educate builders about the proper installation practices.

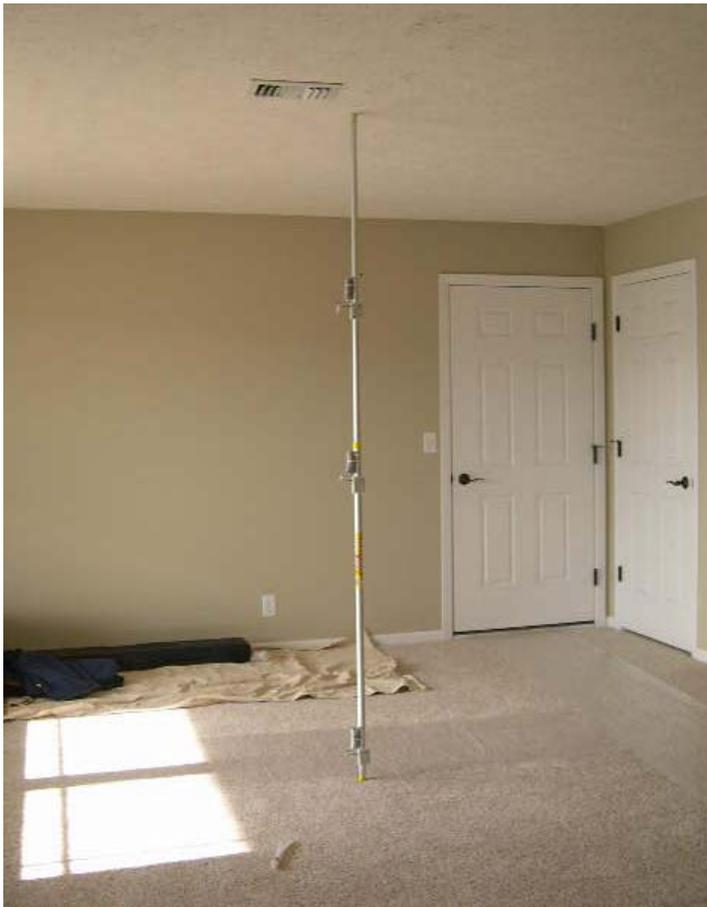
Living Room Sensors

To evaluate the effectiveness of this design strategy, CARB installed seven HOBO temperature sensors in the home. Each sensor scanned the temperature of the space at three minute intervals and logged the temperature data for one week. The test period lasted from February 20-26, 2005. As shown in the photographs below, sensors were installed in two different rooms. The first set of sensors was installed in the main living space at the front of the home, which faces South. The second set of sensors was installed in the Master Bedroom, which is on the North West corner of the home. The last sensor was located next to the thermostat to monitor the overall space temperature.

CARB followed the test protocol established in ASHRAE *Standard 55-2004, Thermal Environmental Conditions for Human Occupancy*. The sensors were located near the center of the room and approximately 3 feet from exterior walls or windows. In each room, the air temperature was measured at three heights: 4 inches, 43 inches, and 67 inches from the ground. The thermostat was set for a constant temperature of 72° F for the entire test period.

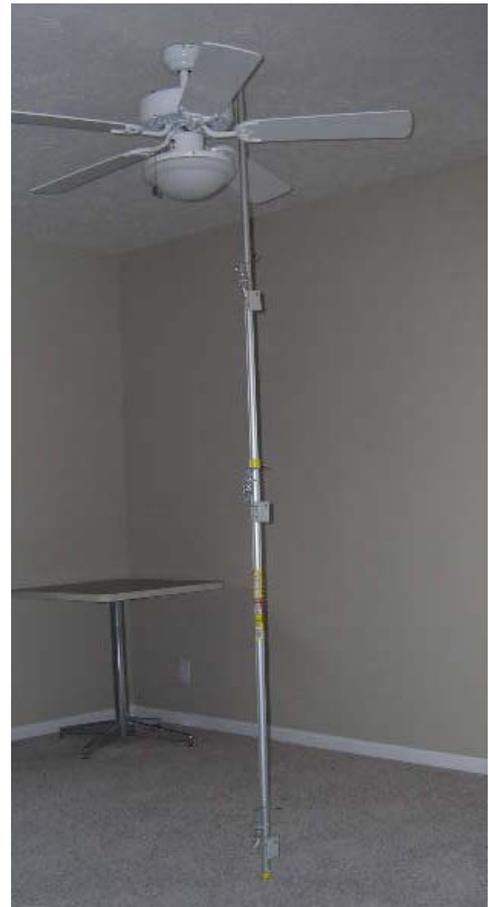
Master Bedroom Sensors

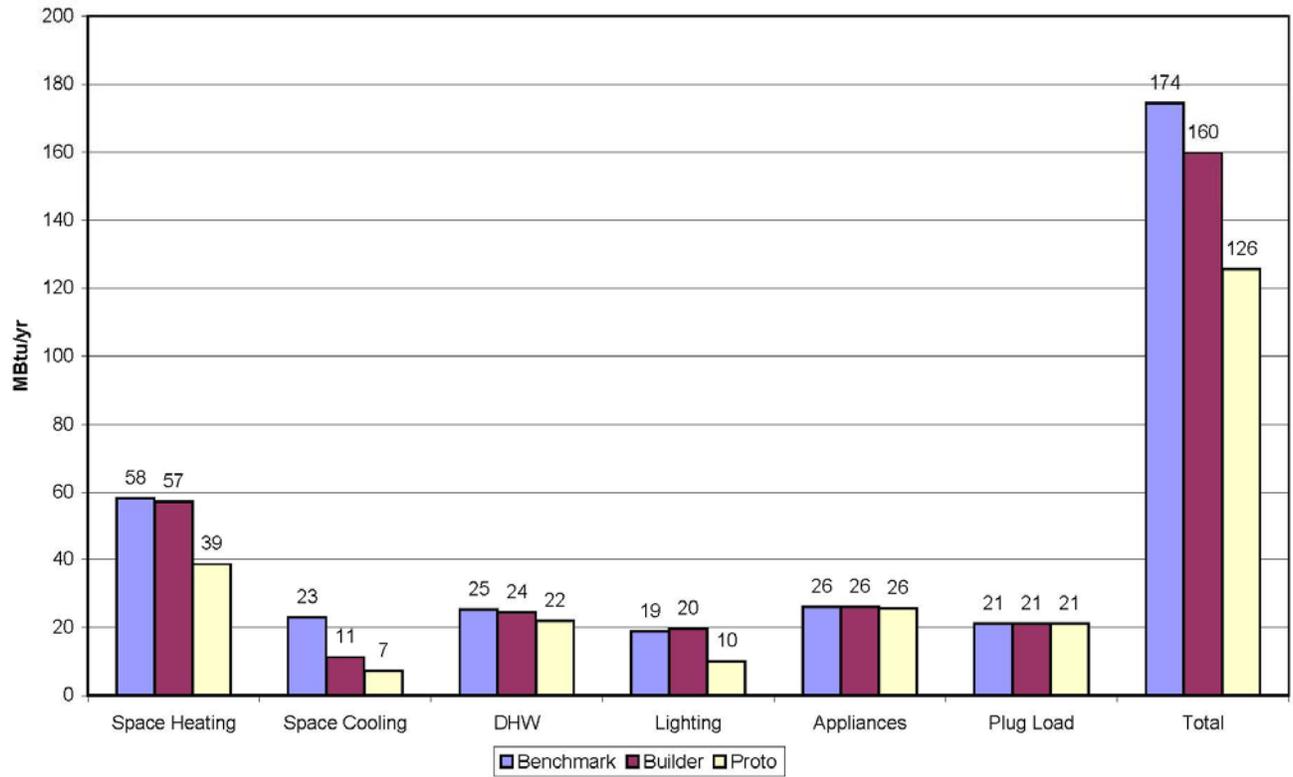
### Source Energy Comparison of Nebraska - Single-Family
